R.O. Cirimello, R. Olezza

Comisión Nacional de Energía Atómica - Argentina

ABSTRACT

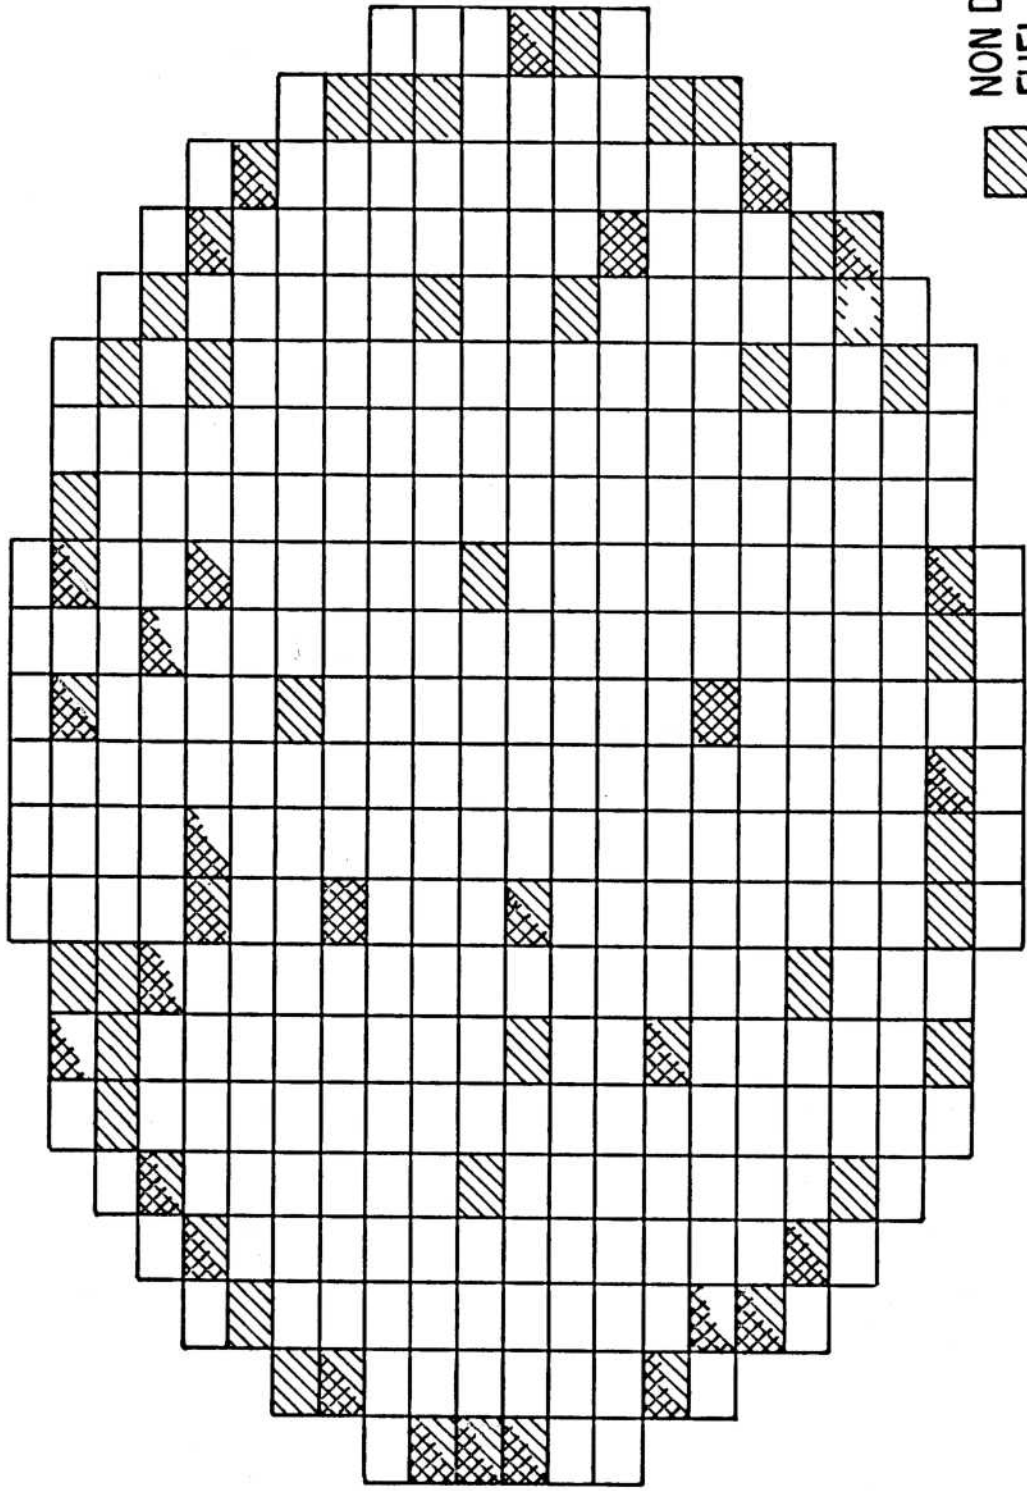
FIGURE 4

The result obtained from the irradiation up to that moment caused that some modifications in the set criteria were performed. So, the quantity of fuel bundles previously fixed for being loaded was increased, but instead of introducing them in the central channels, they were mainly loaded in the outer ones (Fig. 4).

In August, the defected fuel location system identified six suspicious channels.

As time passed, the number of suspicious channels and the activity levels increased. Because of that, it was necessary to begin unloading the most endangered channels. This process was precipitated in December 1985.

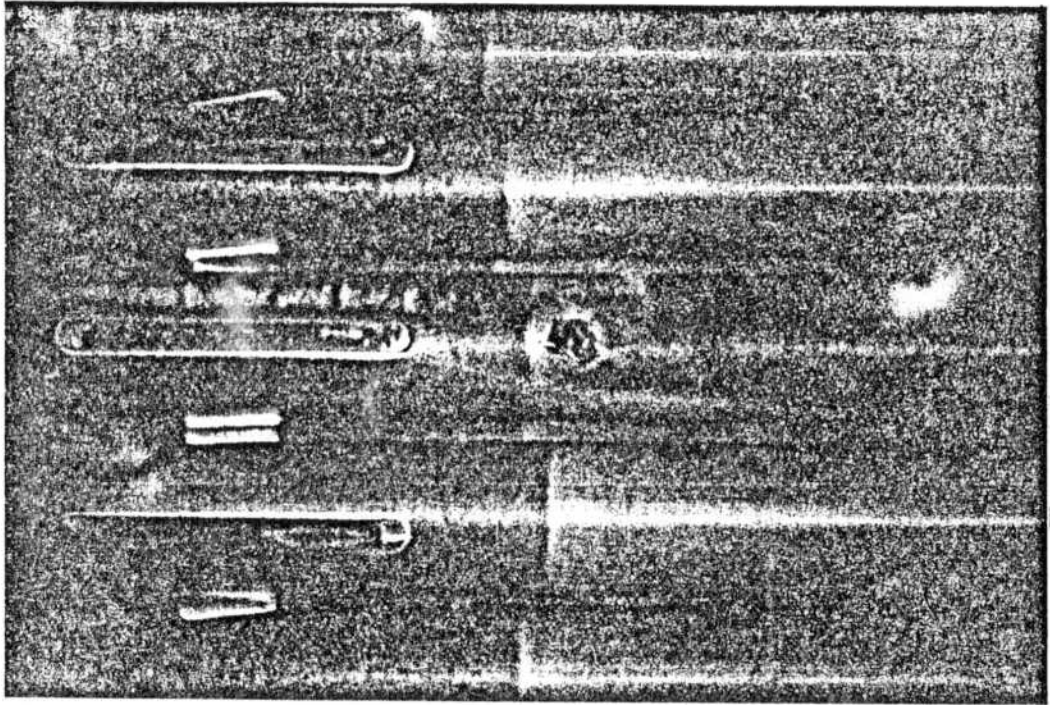
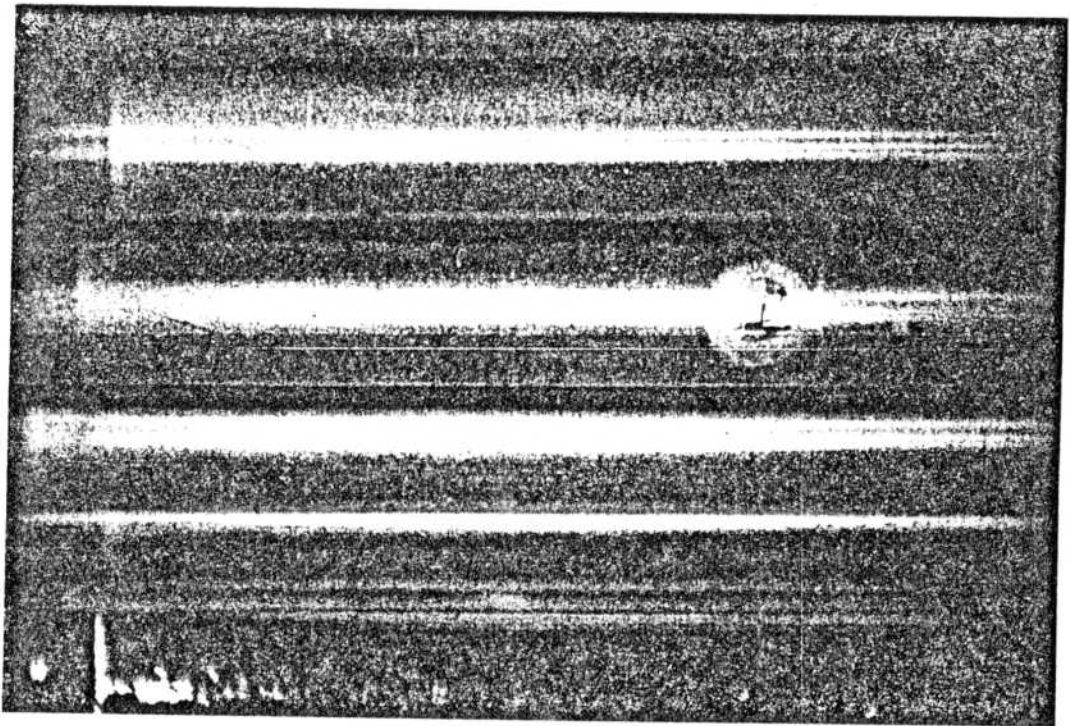
FIGURE 5

The observation of defects led us to conclude that they were of secondary type. It was not possible to find evidence of primary defects, even in the end caps welding zone.

Each of these fuel bundles presented a visible piercing defect, of the kind of that presented in Fig. 5.

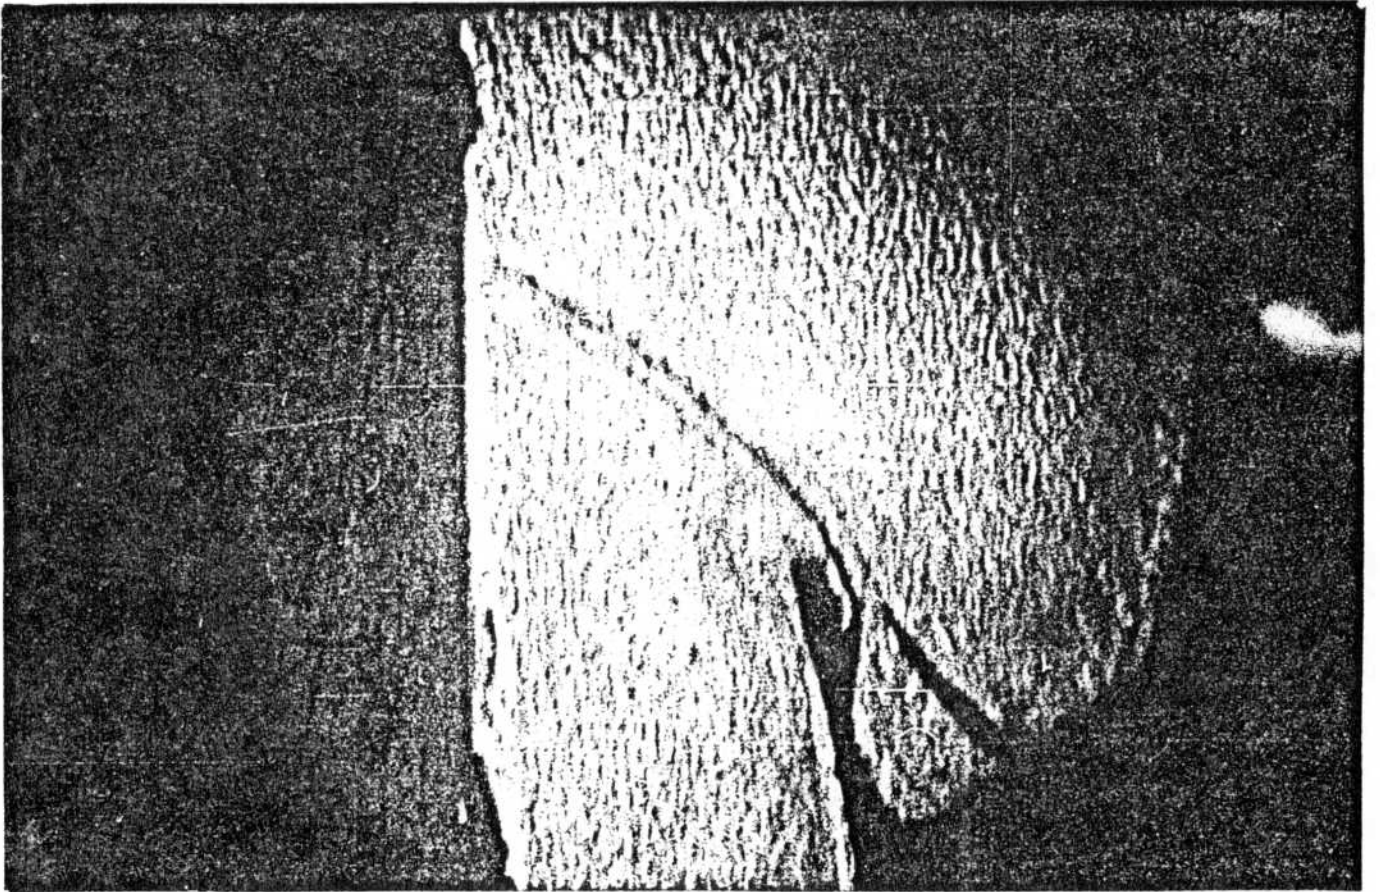
FIGURE 6

These tests, performed in dry boxes, confirmed the existence of cracks in the welding zones as that presented in Fig. 6.

In the welding zone, a lack of continuity of the material can be seen. This has a maximum average width of $5\ \mu\text{m}$ and extends circumpherentially in no more than 1 mm.

The defects morphology was similar to that detected in the quality controls of rejected manufacturing batches.

The epidemic-type of failures was related to the particular geometry of resistance welding clap electrode.

The manufacturing controls performed were based on statistical samplings that reduced the probability of detecting these kinds of defects.

The helium leak test was also inefficient for detection, because cracks developed and punctured the cladding during service.

In the production area, a manufacturing trace-back was performed with the help of documentation. After this, corrective actions were applied to the end cap welding operation.

We have selected as welding processes the most advanced one from the point of view of metallographical processes but severe dimensional control are necessary for the welding electrode.
