# Corrosion monitoring of post-tensioned strands at the Piedra del Aguila spillway

A.L. Burkart, National Atomic Energy Commission, Argentina  
G.S. Duffó, CONICET and Universidad Nacional de San Martín, Argentina  
P. Castro, Hidroeléctrica Piedra del Aguila SA, Argentina

The Piedra del Aguila project in Argentina is a concrete gravity dam constructed in the 1980s, on the Limay river. The dam includes a spillway channel controlled by four gates. The spillway structure includes several post-tensioned systems installed in the concrete piers. These systems do not meet the cable protection standards of modern methods, which provide two barriers against corrosion and can be monitored. In 2004, several leaks were detected that could have reached the steel tendons. Because of this, an innovative programme was developed to ascertain the integrity and remaining life of the steel strands. This paper presents a summary of the activities performed and the instrumentation installed at Piedra del Aguila to assist with the long-term monitoring of the dam.

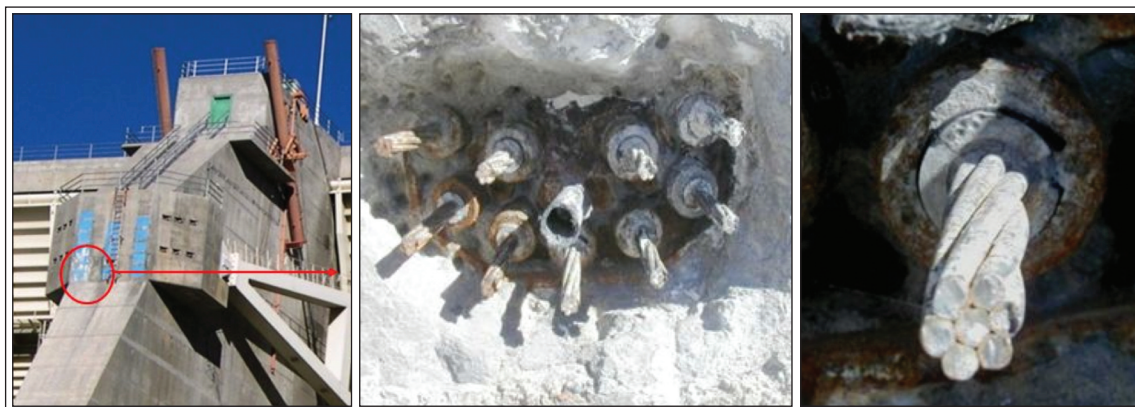
From left: (c) View of one of the piers studied. (d) Network of the fully grouted post-tensioned strands. (e) Detail of a strand.

The integrity of the spillway's piers, and especially the trunnions, is assured by a network of 21 fully grouted post-tensioned tendons (strands) placed longitudinally along the pier wall, between the dam wall and the trunnions, distributed in an area of 1 m<sup>2</sup>, see photo (c).

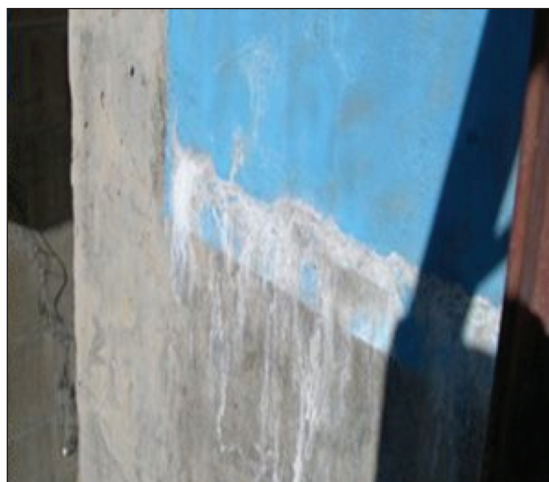
Drainage of water saturated with carbonates, as indicated by the white spots that had been deposited, was detected at several of the trunnions' front faces downstream of the dam wall, as can be seen in picture (f). This indicates that the reservoir water was able to diffuse through the concrete voids from the reservoir to the spillway pier's trunnion so there was a high probability that water had come in contact with the embedded steel tendons.

Carbonation (leaching compounds) residue was detected on some of the trunnion front faces downstream, as can be seen in picture (f). It was probably then that small defects in the concrete upstream face of the dam caused leakage and water subsequently reached the trunnions.

(f) White spots of leaching material on the surface of the walls.

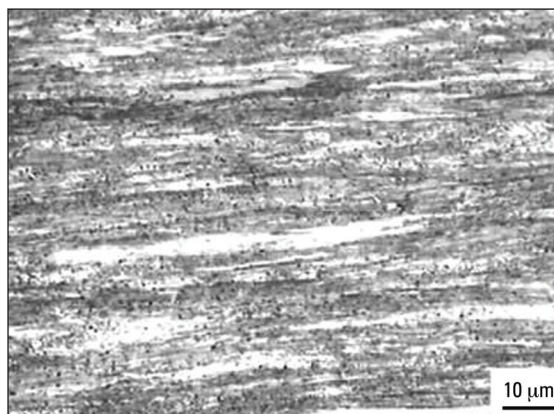
This composition fits the requirements of an SAE 1070 high strength steel. From the metallographic analysis, photo (g) shows that the steel strands have a highly deformed cold drawn banded ferritic-pearlitic microstructure.

(g) A longitudinal metallographic section of the steel strand.

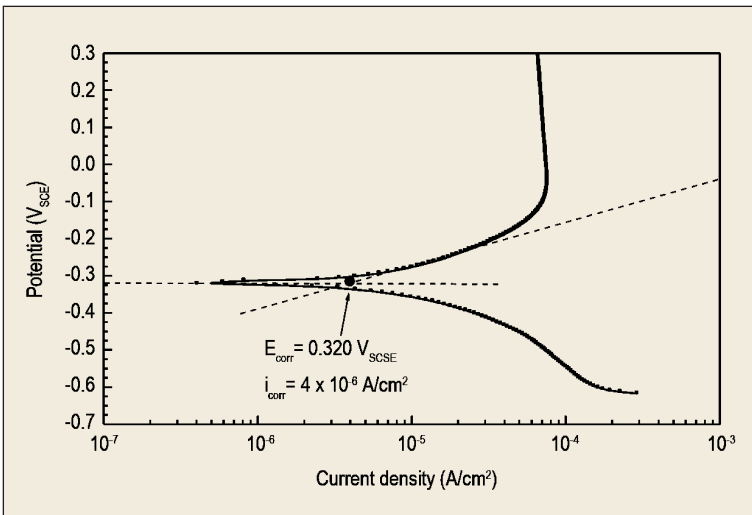
Fig. 1. Typical polarization curve of steel in an A-1 injected water sample, demonstrating how the corrosion current density ( $i_{corr}$ ) is obtained.

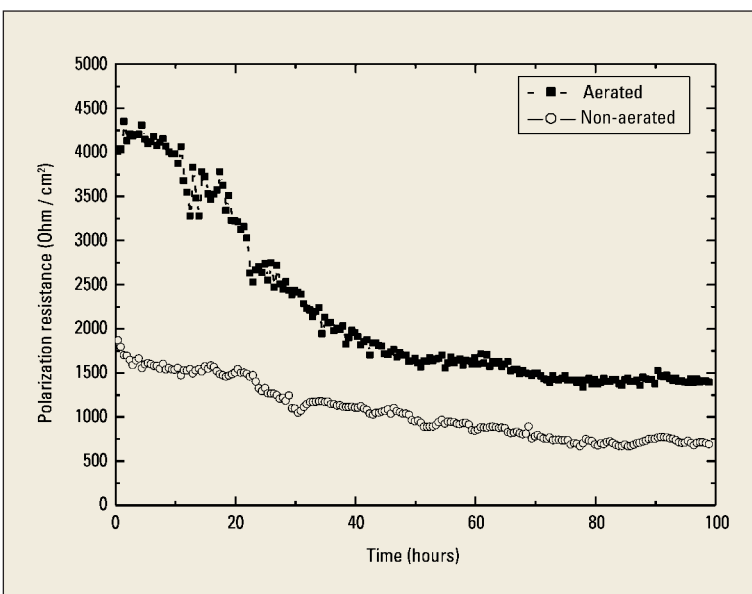
Fig. 2. Evolution of the polarization resistance of the steel in an A-3 water sample, as a function of time.

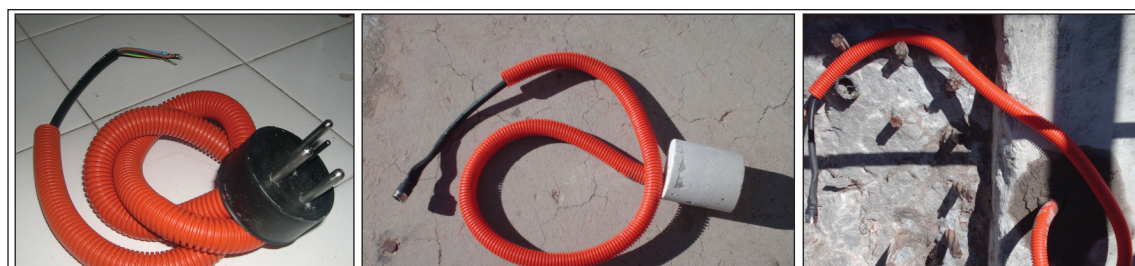
Final appearance of the sensor: (left) before embedding in porous mortar; (centre) after embedding in porous mortar; (far right) sensor installed in pier number 3.

The photos above show the sensor before and after grouting and the installation sites in the gallery and near the unbounded ends of the strands at the trunnions.

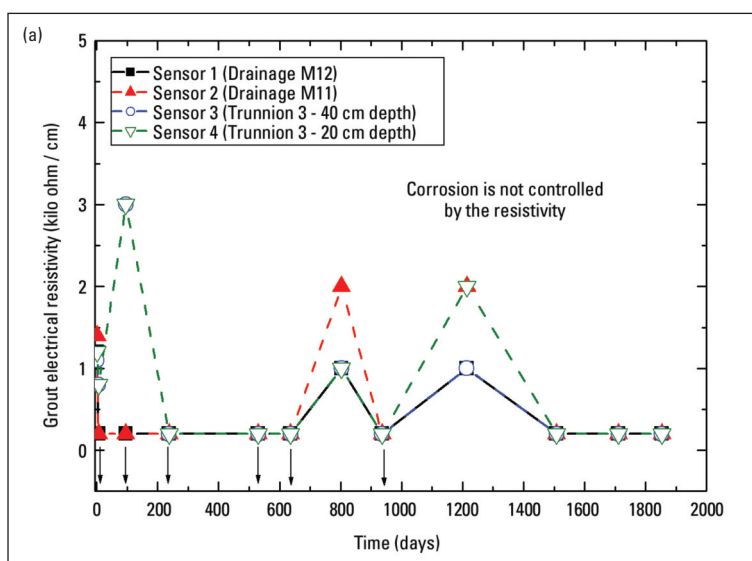
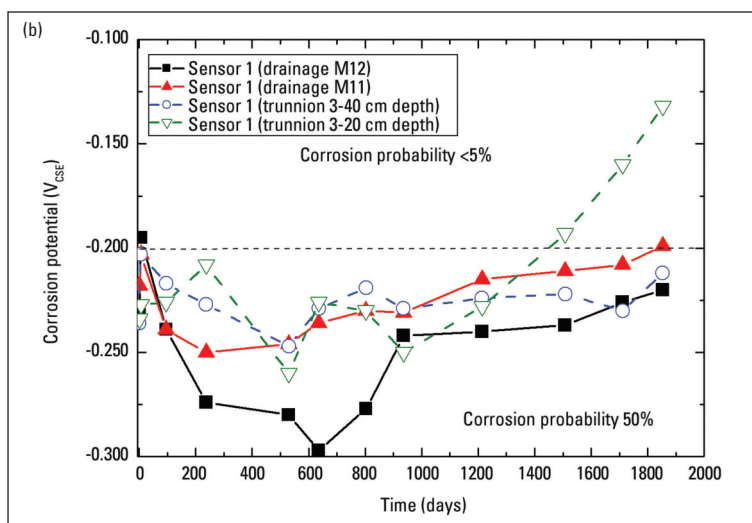
Fig. 3. Results obtained with the sensor embedded in different places: (a) evolution of the grout electrical resistivity; (b) evolution of the corrosion potential.

The parameters directly linked to the steel corrosion process are the corrosion potential, the corrosion rate and the evolution with time, which are shown in Fig. 3. The thermodynamic parameter (the corrosion potential) shows values below  $-0.200\text{ V}_{\text{CSE}}$ , indicating certain corrosion risks (50 per cent corrosion likelihood). Nevertheless, the tendency clearly shows an increasing trend of the corrosion potential with time, up to a level close to the low corrosion probability. This trend is particularly clear at the trunnion monitoring site.
