R.O. Cirimello, R. Olezza

Comisión Nacional de Energía Atómica - Argentina

ABSTRACT

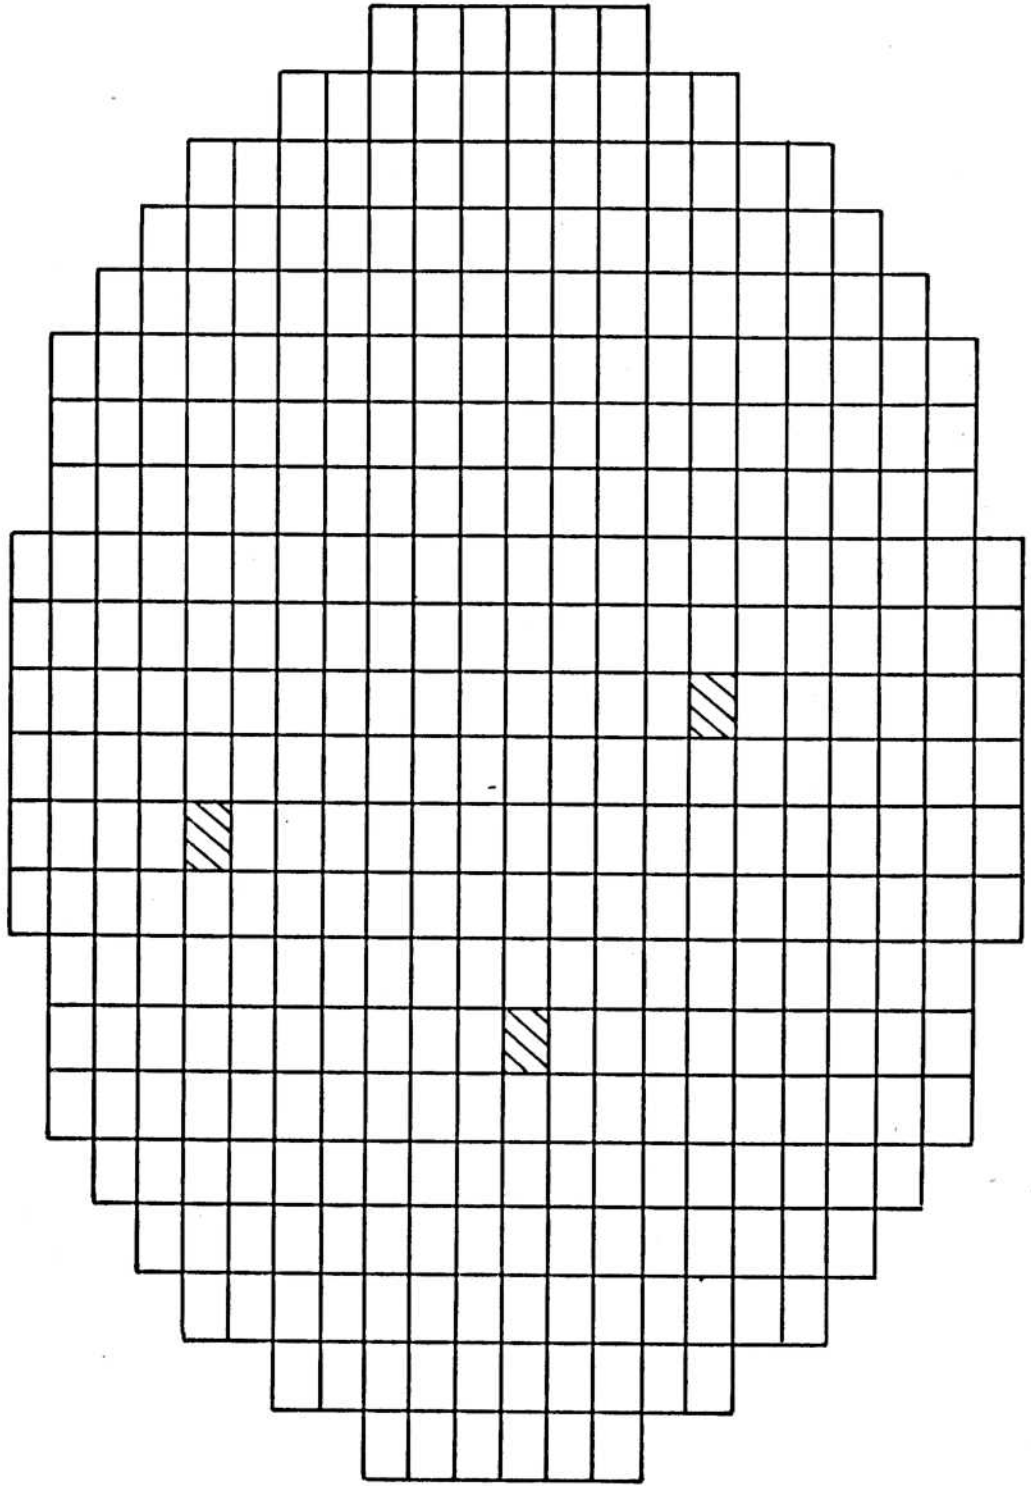
FIGURE 3

After Power Station contractual provisional acceptance, the loading of fuel in the reactor was started. Thirty six fuel bundles were loaded in the three channels pointed out in Fig. 3.

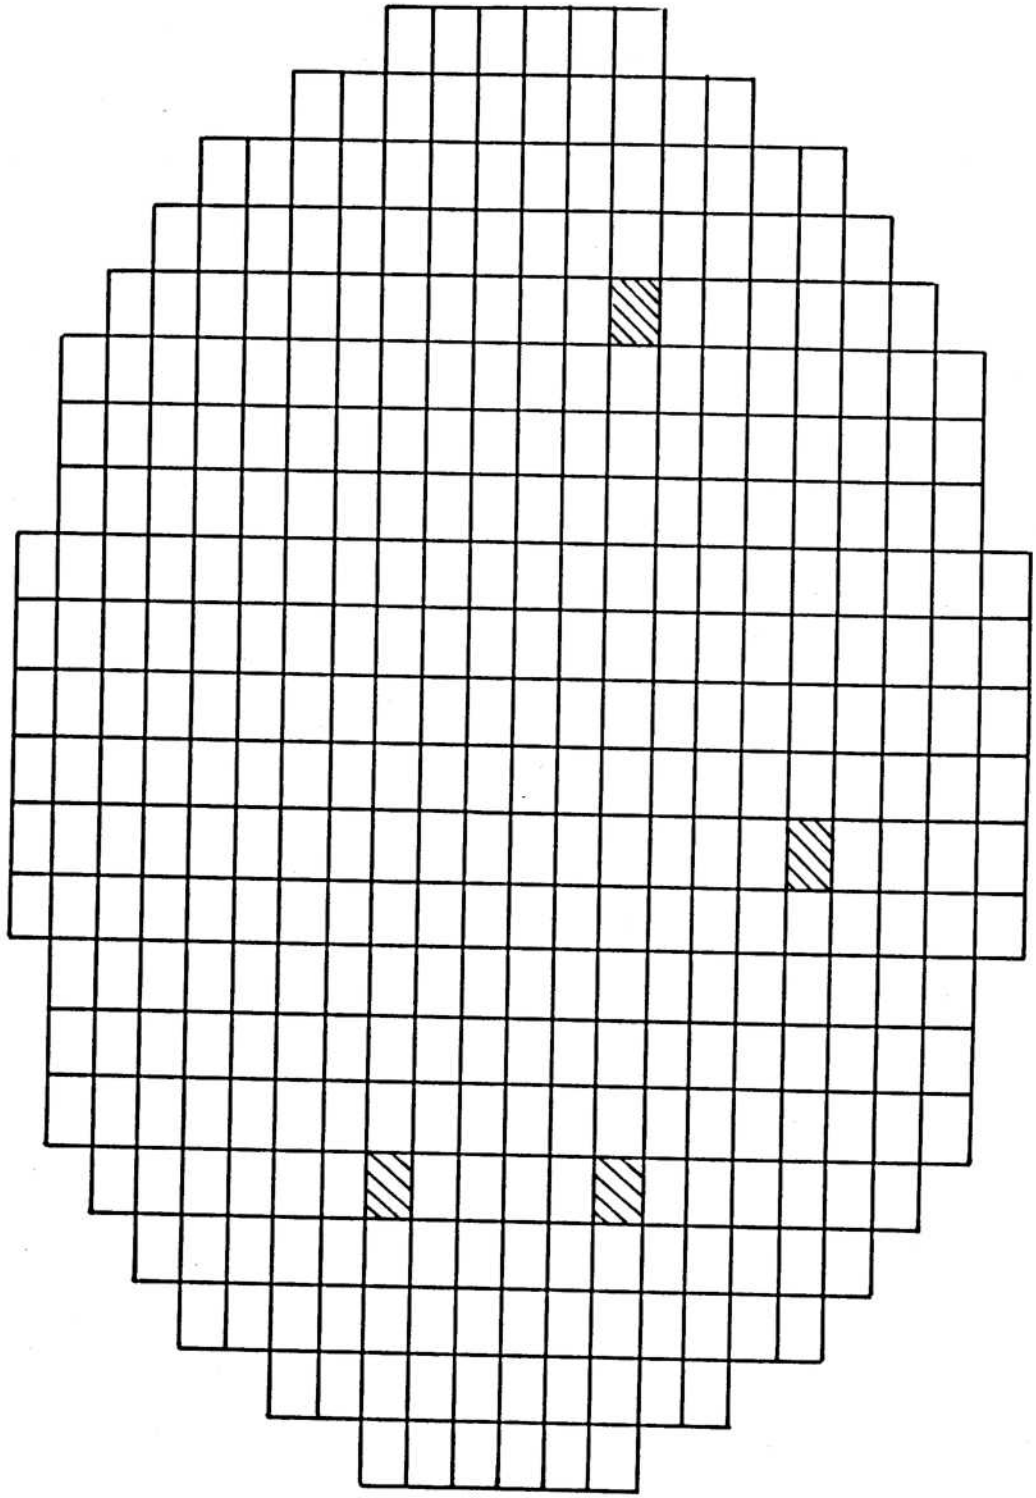
FIGURE 7

After corrective actions, the irradiation program was re-started last February, when 32 fuel bundles were loaded in the channels pointed out in Fig. 7.

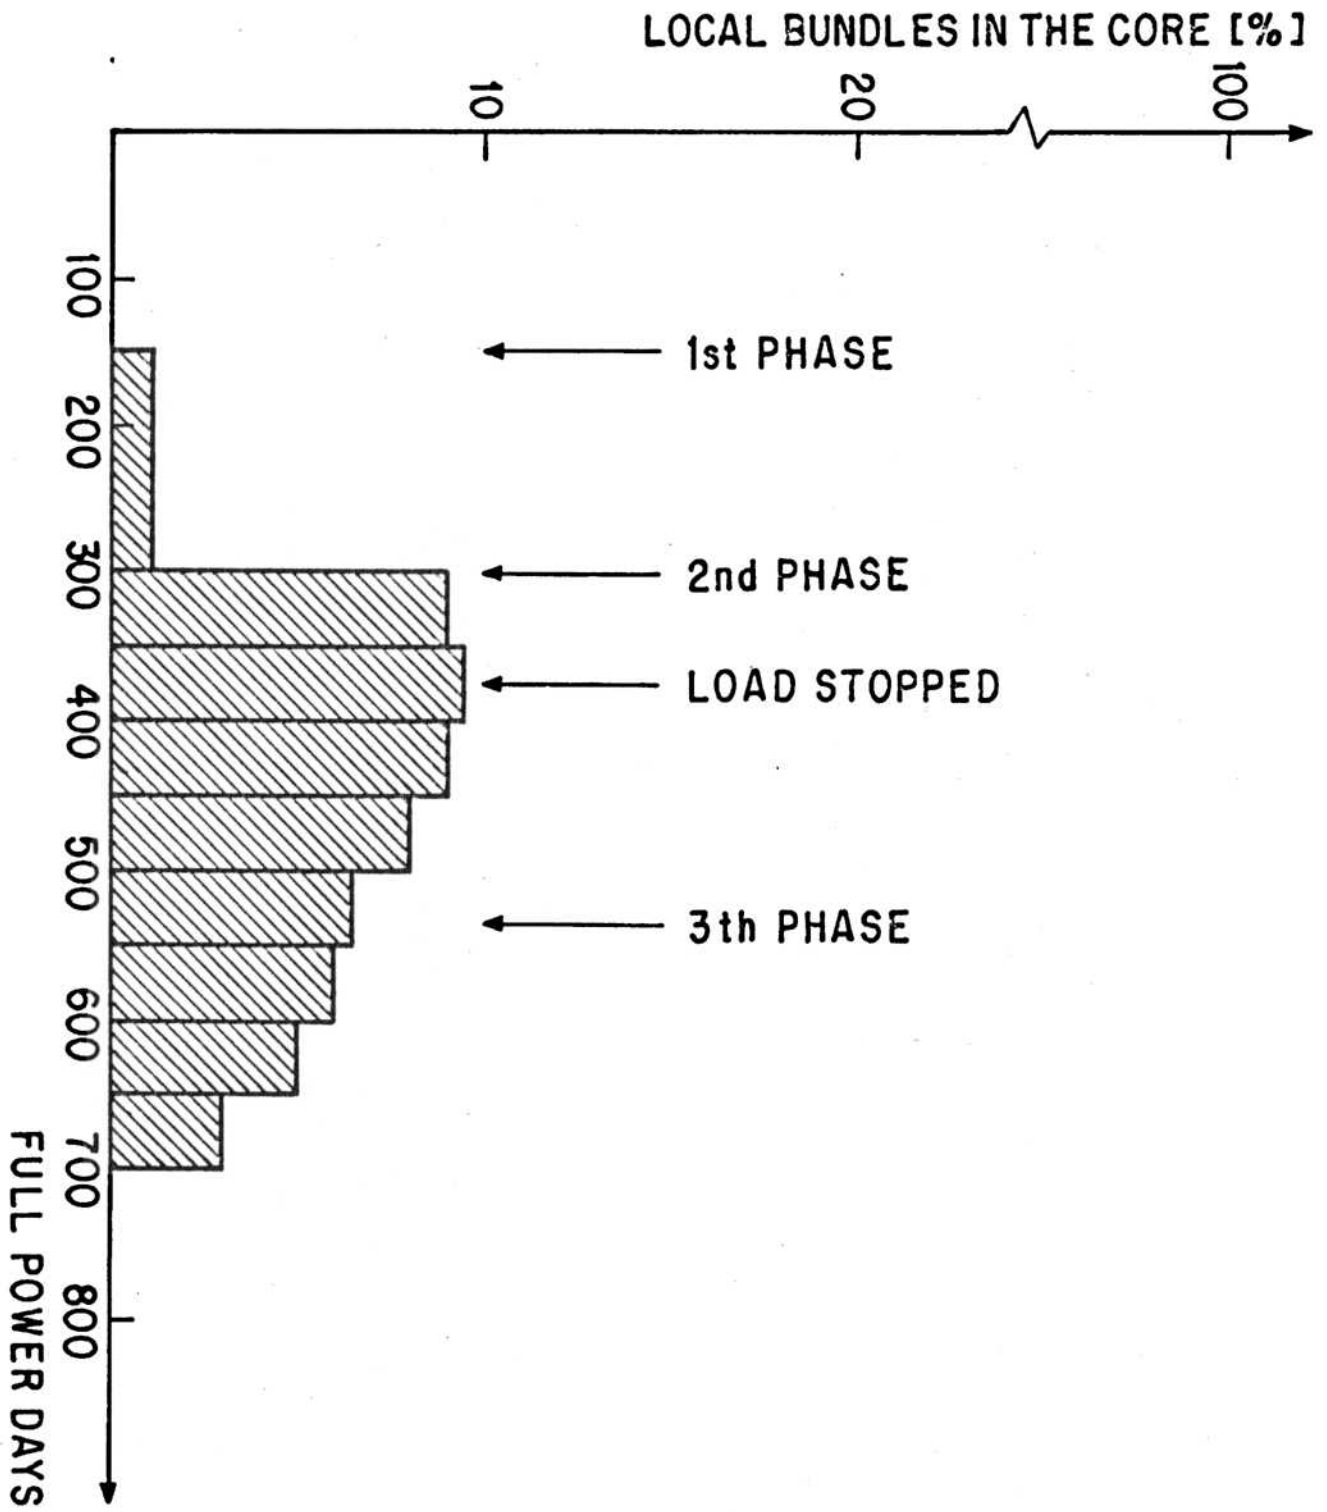
FIGURE 8

The maximum quantity of domestic fuel bundles simultaneously operating in the reactor was of 468. Fig. 8 shows the evolution of all the fuel bundles loades since the beginnings of the program.
